**1977-1978 WINTER TEST  
SITE REPORT  
FOR  
PERIPHERAL PARKING AREAS**

XIII OLYMPIC WINTER  
GAMES · LAKE PLACID · 1980

**PREPARED  
FOR  
OLYMPIC  
TRANSPORTATION  
COMMITTEE**

**SOIL MECHANICS BUREAU  
NEW YORK STATE  
DEPARTMENT OF TRANSPORTATION**

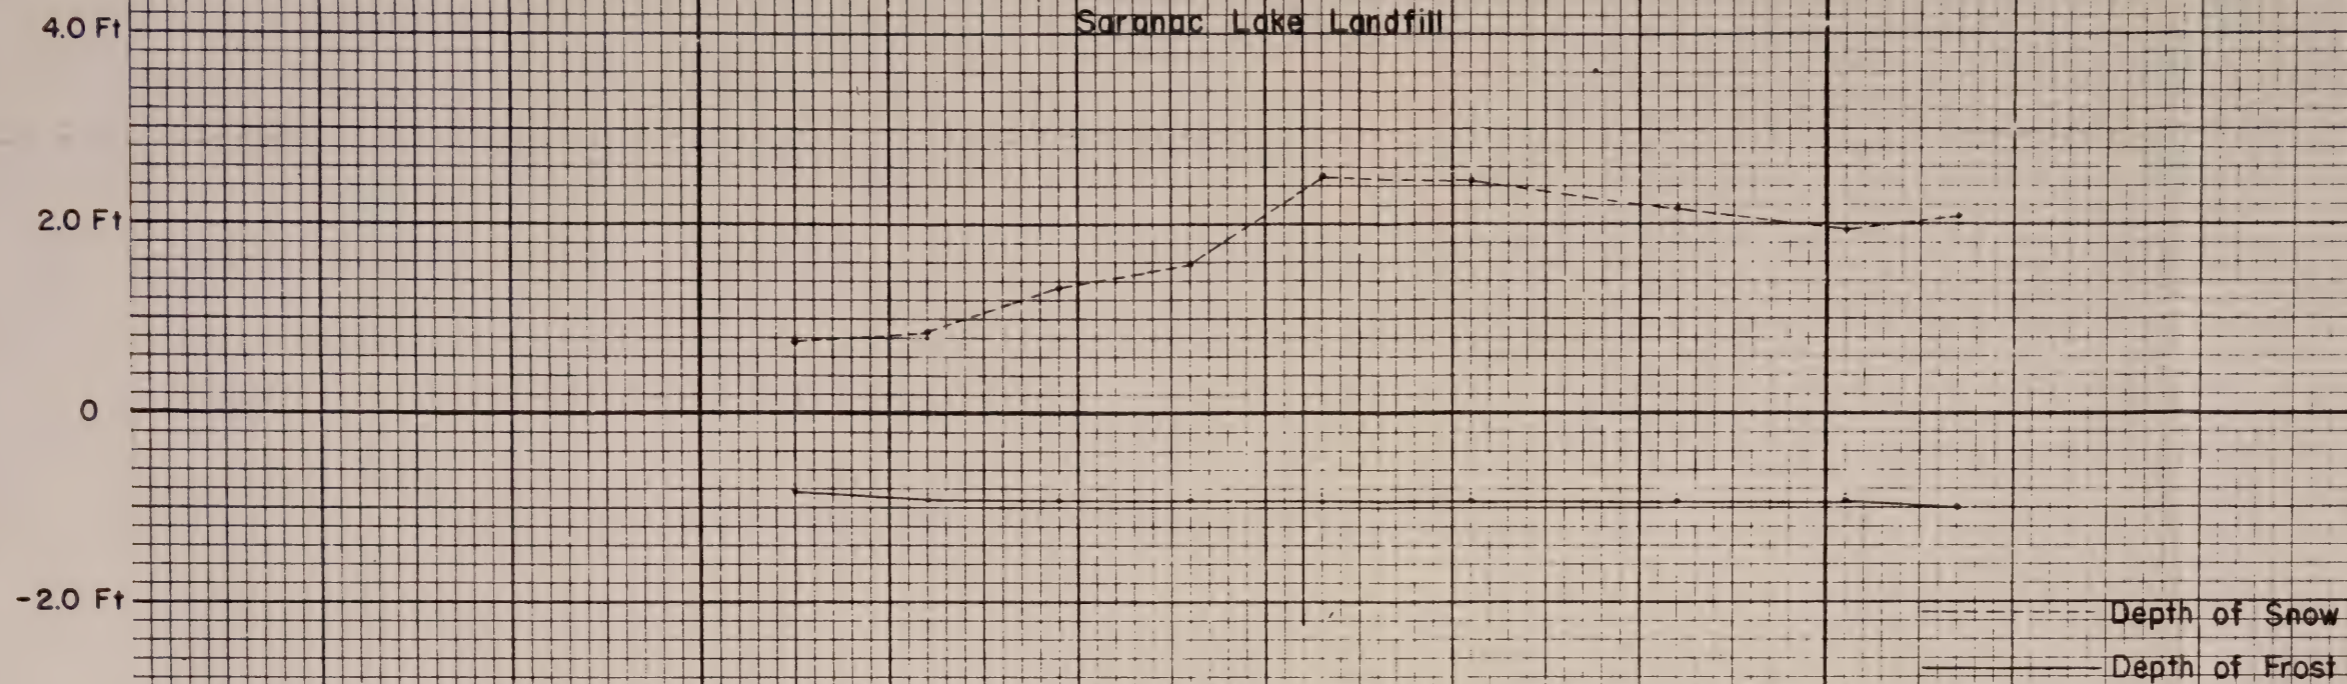
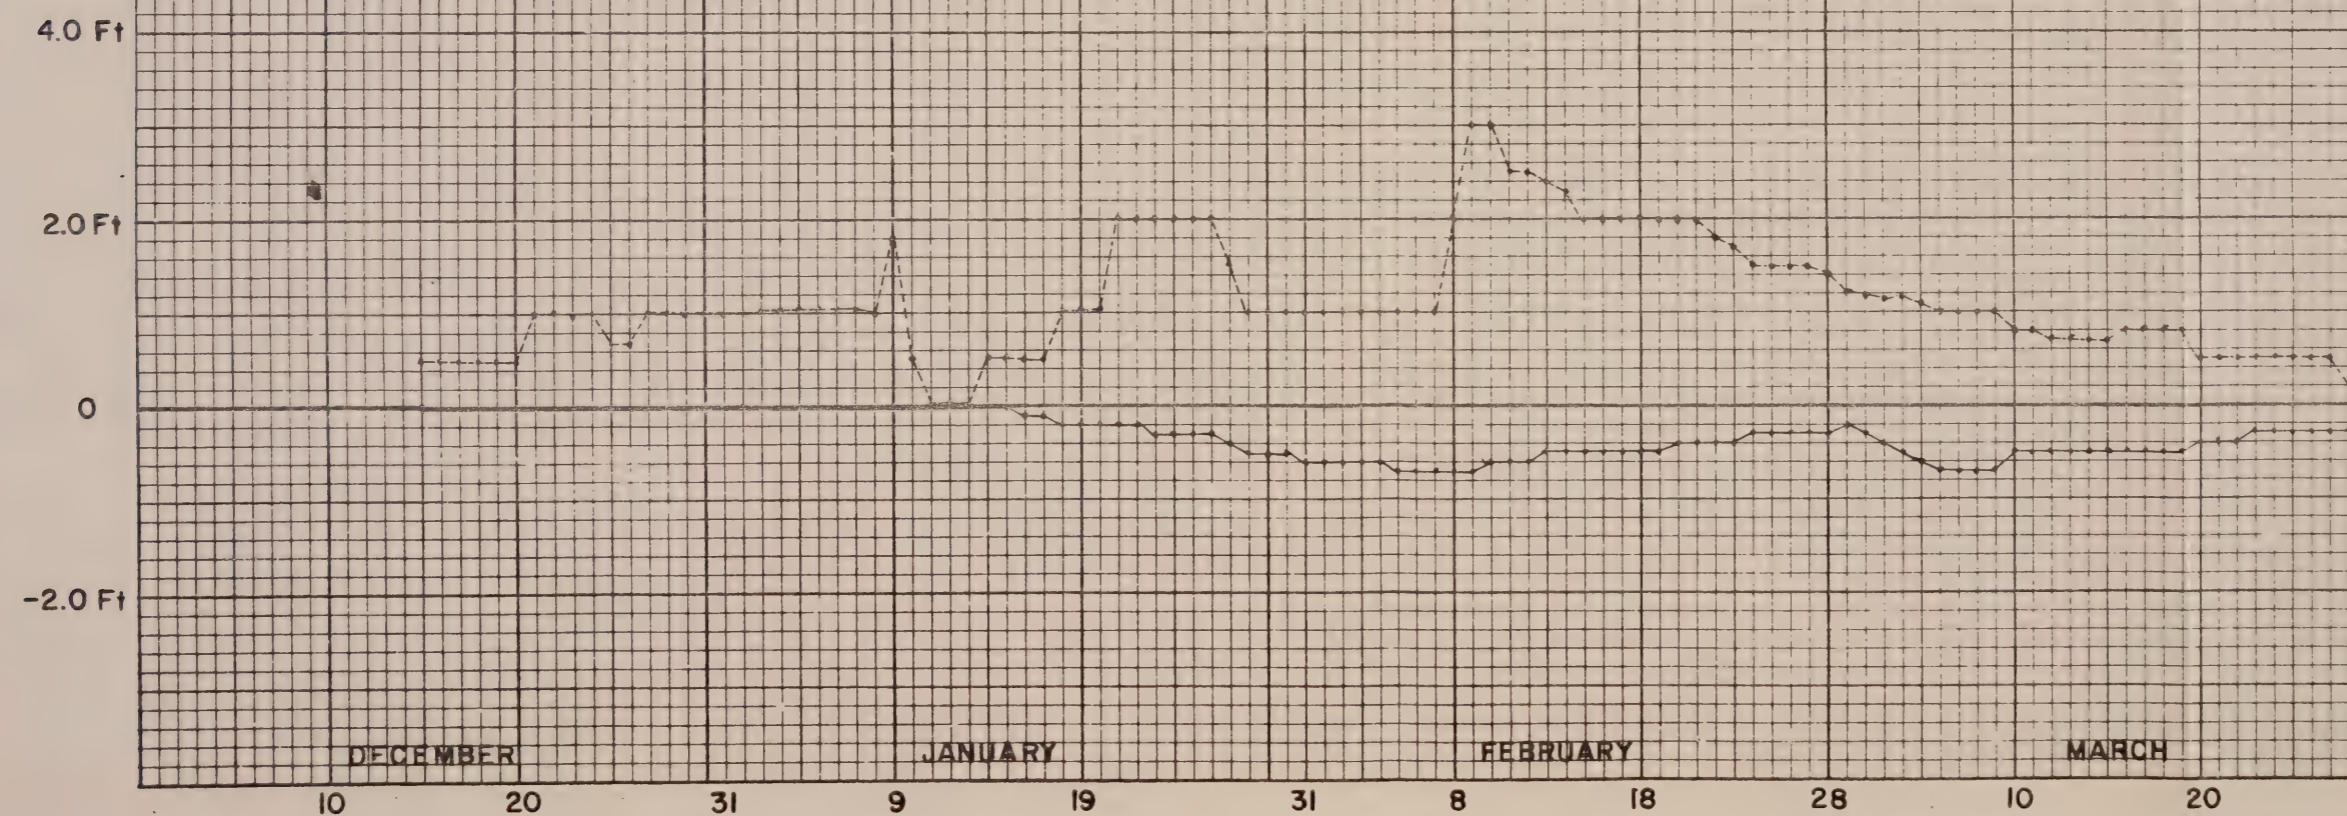
FIGURE B-5

SNOW AND FROST DEPTH RECORDS

Saranac Lake Landfill

Marcy Airfield Test Site
